Manhole Inspection Summary

Manhole # S17II_035MH

Insp Date: **3/18/09 9:01 AM**

Location Address: **2400 PRESBURY ST**

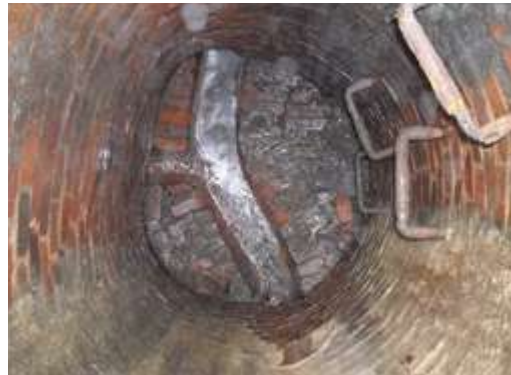
Top View

Comments **OBSERVED STUCK AND BROKEN COVER - REMOVED USING JACK AND BOLT METHOD - INSPECTION COMPLETE - REPLACED LID WITH NEW 24" SANITARY.**

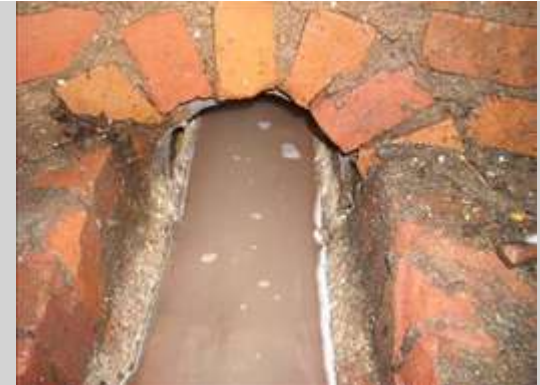
12 O'Clock Outflow

10 in. Circular Gravity Sewer
Pipe Out @ 12 O'Clock

Pipe Height: **9.6** (in.) Rod and Bar (Angled)
Pipe Material: **Clay** ☐ Pipe Lined
Invert Depth: **8.84** (ft.) Flow Characteristics: **Slow**
Deposits: ☒ None ☐ Mud ☐ Sludge ☐ Debris ☐ Grease
Silt Depth: (in.) Deposits Extent:
Infiltration: **None** Pipe Seal Cond: **Sound**

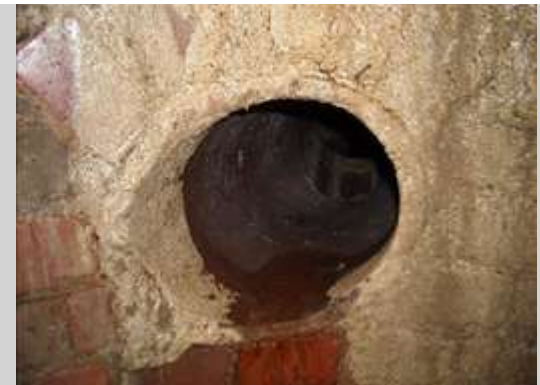
5 O'Clock Inflow

8 in. Circular Gravity Sewer
Pipe In @ 5 O'Clock

Pipe Height: **8.4** (in.) Rod and Bar (Angled)
Pipe Material: **Clay** ☐ Pipe Lined
Invert Depth: **5.58** (ft.) Flow Characteristics: **Slow**
Deposits: ☒ None ☐ Mud ☐ Sludge ☐ Debris ☐ Grease
Silt Depth: (in.) Deposits Extent:
Infiltration: **None** Pipe Seal Cond: **Sound**

Drop: **Inside** Rod and Bar
Angled: **Yes** Reading: **7.71** (ft.)
Inv Depth: **8.71** (ft.)

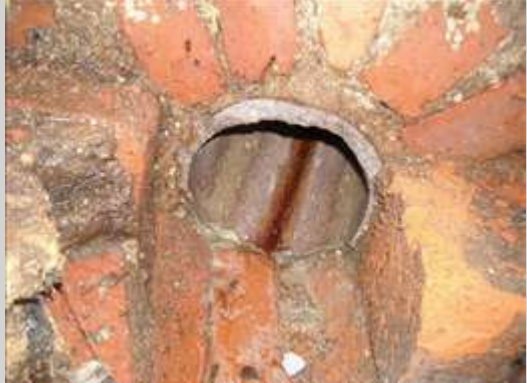
9 O'Clock Inflow

6 in. Circular Gravity Sewer

Pipe Height: **6** (in.) Rod and Bar (Angled)
